Mission possible: how Sulzer repaired a damaged municipality turbine in just 28 days

Gas turbine repairs can be particularly complex, especially when they experience blade failures that cause additional consequential damage. However, downtime for a power generation company can be extremely expensive, which led one Californian municipality to call on Sulzer to complete the repair to their damaged turbine in just 28 days.

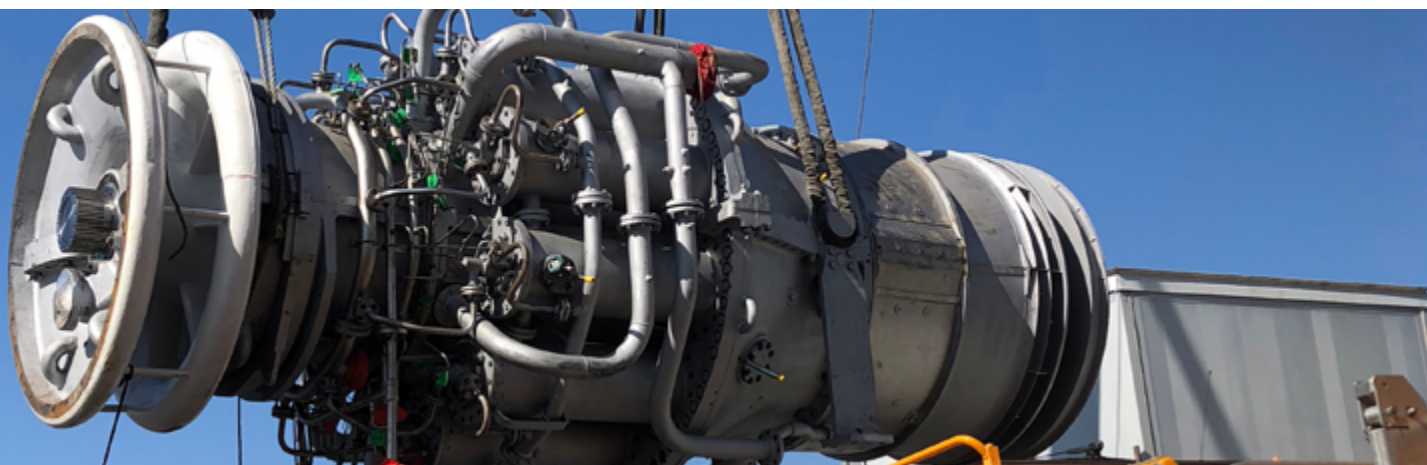
Installation of the new thermal block onsite.

However, within Sulzer's inventory there was another thermal block of the same specification that had been partially repaired, but was no longer required. The workshop team in Houston completed the repairs to this thermal block so that it could be installed as a replacement.

The scheduling of these two stages was very important because when the time came to lift the damaged thermal block and load it onto a truck, the replacement needed to be waiting nearby, ready to be craned into position. This ensured the fastest turnaround on the project and minimized the cost of craneage for the customer.

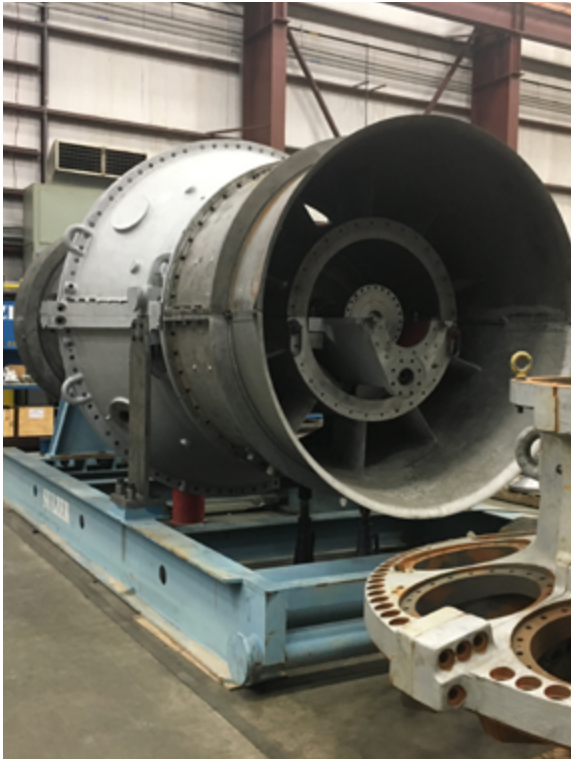
For one Californian municipality, the location of two of its 20 MW gas turbine generators presented a significant problem with corrosion, as the facility was only a mile from the ocean. In fact, the situation had reached the point where one unit had ingested a stator blade into the compressor and traveled through the turbine.

The original gas turbine thermal block was inspected and found to be beyond economic repair.

Having removed the damaged unit, it was inspected by Sulzer's engineers and deemed to be beyond economic repair. This means that, without Sulzer's intervention, the customer would have been looking at finding a new turbine or a new thermal block, most likely from the original equipment manufacturer (OEM). However, the lead time for these components is considerably greater than 28 days.
